**Coal Combustion Residue Impoundment
Round 9 - Dam Assessment Report**

*H.L. Spurlock Power Station
Spurlock Ash Pond
East Kentucky Power Cooperative
Maysville, Kentucky*

Dewberry & Davis, LLC
Fairfax, Virginia

Under Contract Number: EP-09W001727
December 2011

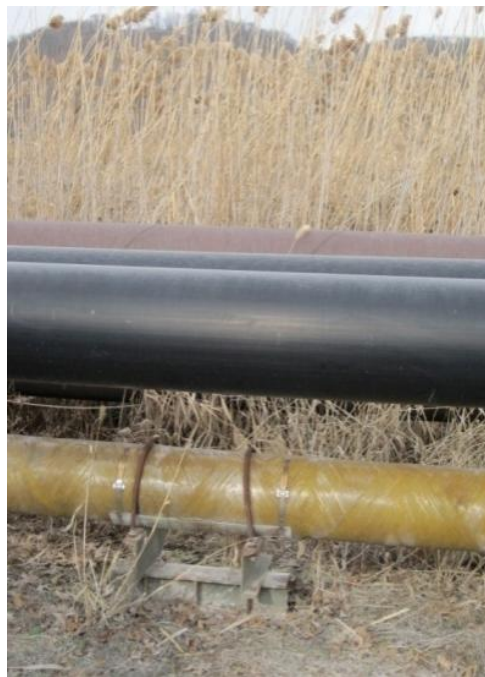
Figure 2.2.2.5: HDPE (Black) Pipes Transporting CCR (Bottom Ash) from the Plant to the Pond; Fiberglass Pipe (Lower) and Metal Pipe (top) are Abandoned

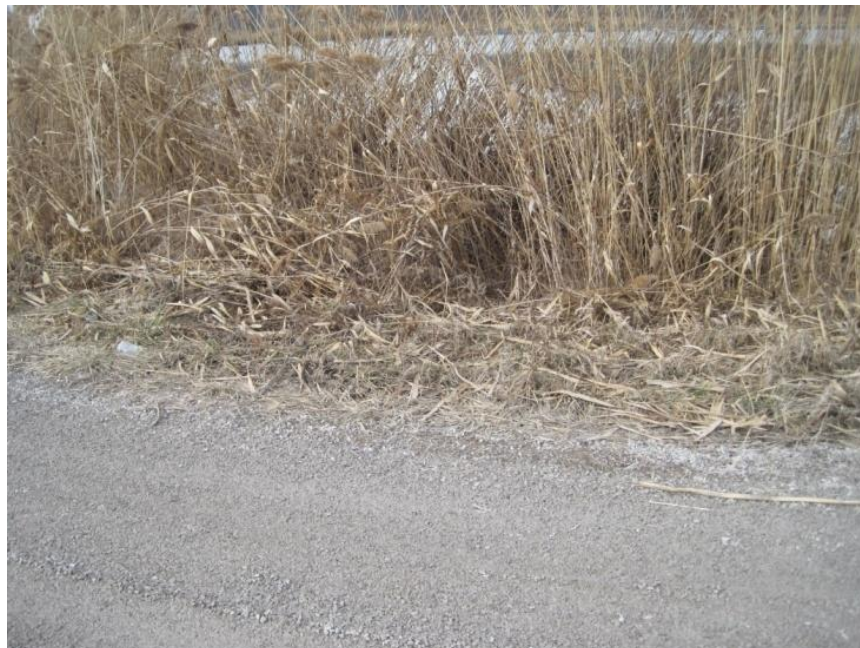
As mentioned in Section 1.1.5, current grades of the interior slopes could not be verified because large segments of the interior embankment were covered by excessive vegetation, specifically tall phragmites (See Figures 5.2.2.1 and 5.2.2.2).

Figure 5.2.2.1: Phragmites Along Inside perimeter of Ash Pond (1 of 2)

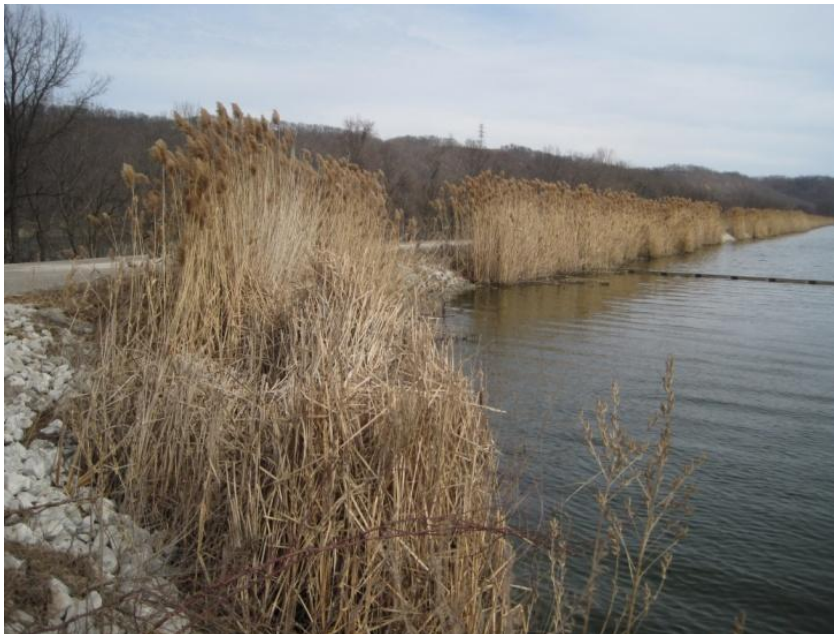
Figure 5.2.2.2: Phragmites Along Inside perimeter of Ash Pond (2 of 2)

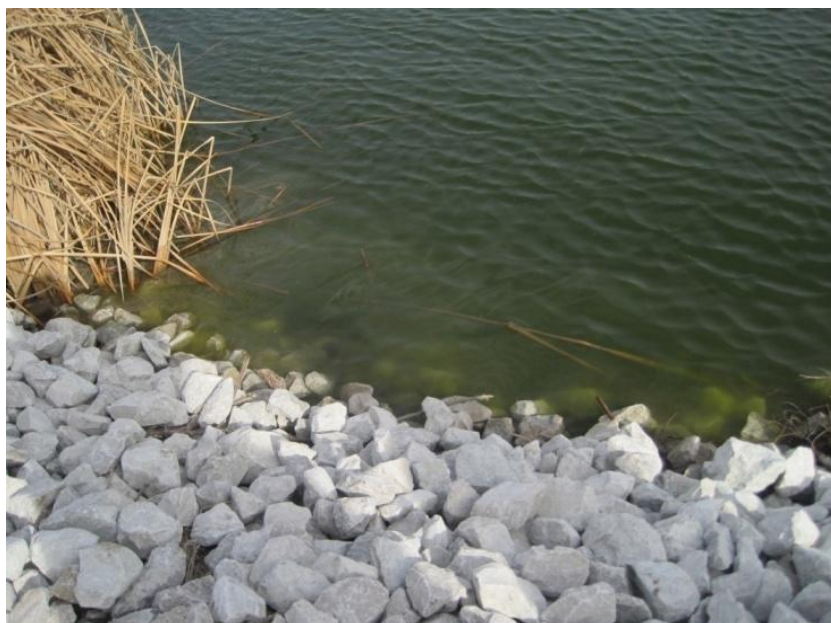
The portion of embankment visually available indicated that the slopes were protected against erosion due to wind, water, and wave action by a layer of 18" thick riprap, and experiencing no erosion (See Figures 5.2.2.3 and 5.2.2.4).

Figure 5.2.2.3: Layer of 18" Thick Riprap Surrounding Inside Perimeter of Ash Pond

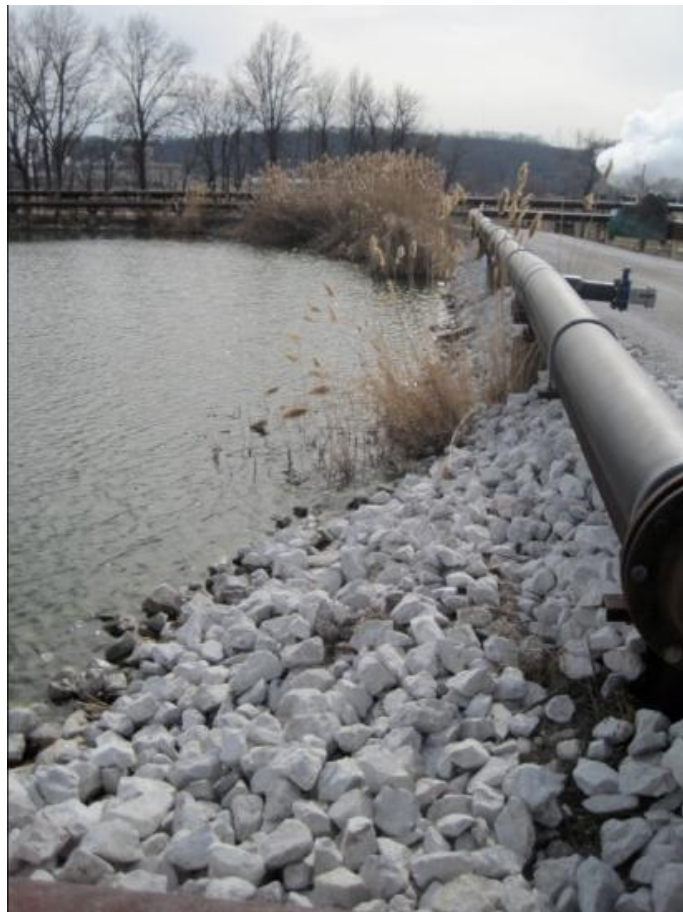
Figure 5.2.2.4: Layer of 18" Thick Riprap Combined with Phragmites Surrounding Inside Perimeter of Ash Pond

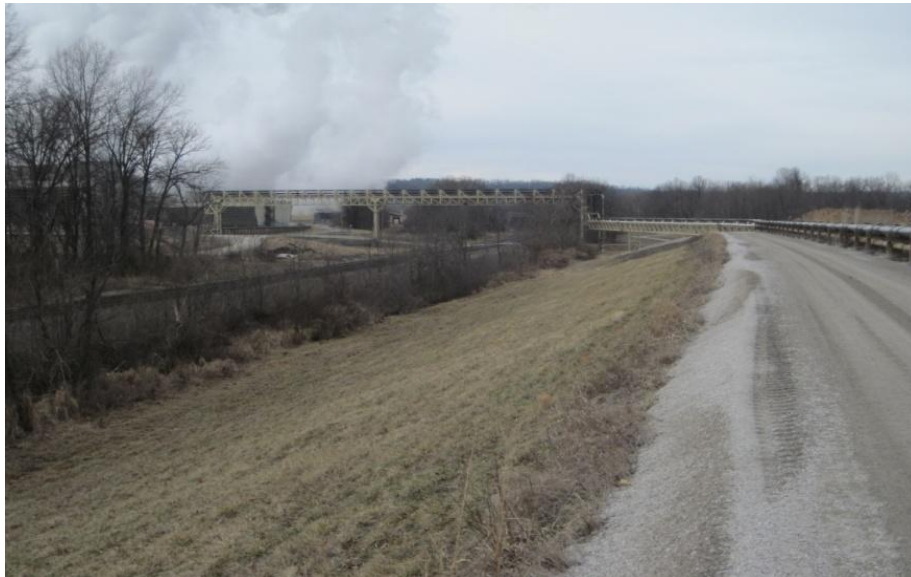
The outside slope of the south and east dike are bordered by parallel ditches that drain to the Ohio River. The outside slope of the north dike runs parallel to and faces the Ohio River. The outside slopes were observed to measure approximately 3:1 with some variances. The exterior embankments were generally in good condition with adequate grass cover and well maintained (See Figures 5.2.3.1 through 5.2.3.4 for the general condition of the North, South, East, and West exterior embankments, respectively). There were no observed scarps, sloughs, bulging, cracks, depressions, or other indications of slope instability or signs of erosion found during this assessment.

Figure 5.2.3.2: S Exterior Embankment

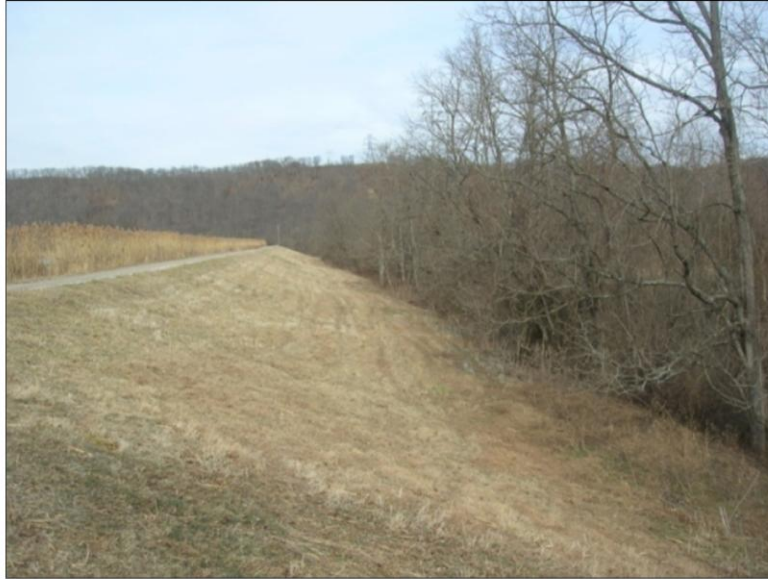
Figure 5.2.3.3: E Exterior Embankment
